CALIFORNIA DIVISION OF MINES AND GEOLOGY

Fault Evaluation Report FER-26

March 7, 1977

1. Name of fault: Arroyo Parida fault (eastern segment) and Santa Ana fault.
2. Location of fault: Ojai, Matilija and White Ledge Peak 7.5' quadrangles, Ventura County; this fault extends westward into Santa Barbara County (see FER-3).

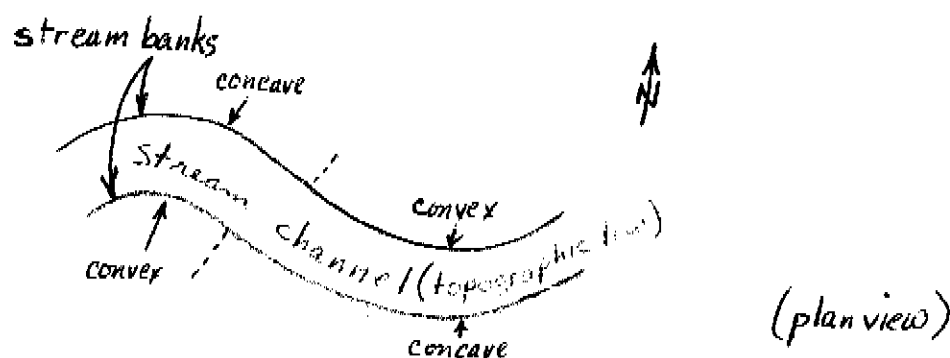
Figure 1.

Two features noted on air photos merit special mention. The first lies between Ojai and Black Mountain (see plate 4). This scarp in late Pleistocene alluvium could be explained as an old channel meander scar. However, the configuration of the scarp differs from that expected of a channel scar. Stream banks are either concave or convex (fig. 1).

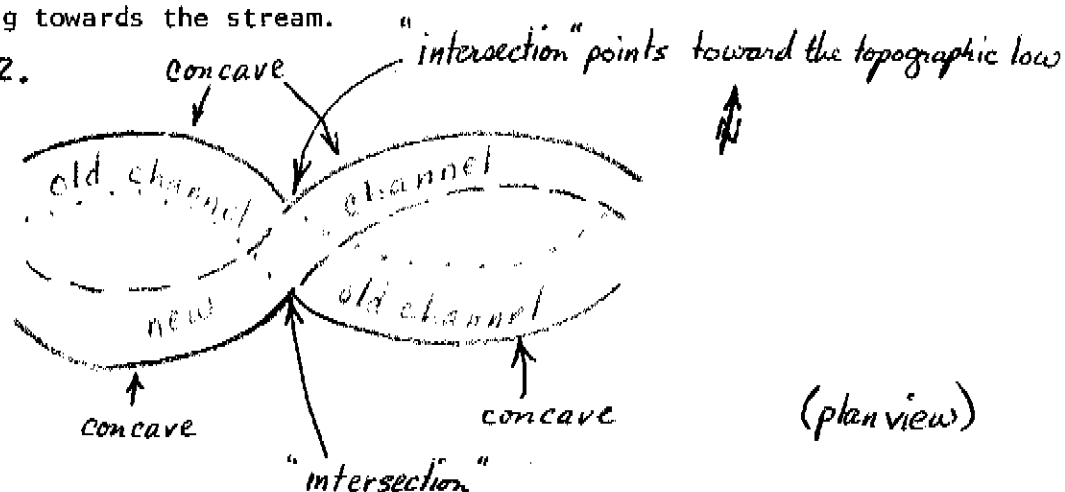
Figure 2.

As the stream changes course, the stream banks tend to become primarily concave (figure 2) with the "intersections" of the old and new banks pointing towards the stream.

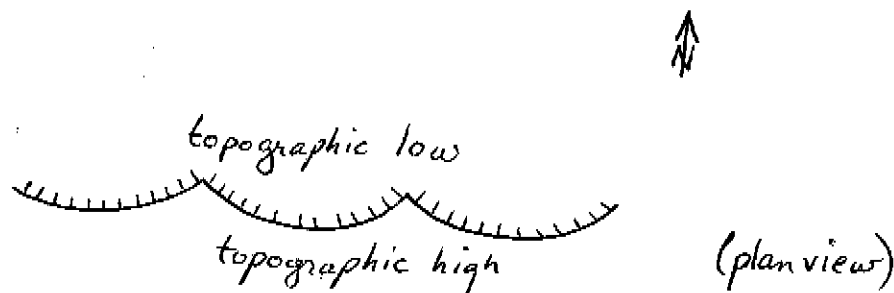
Figure 3.

Thus, if only one bank remained, one could expect to find a "scarp" in this "concave" configuration (figure 3).

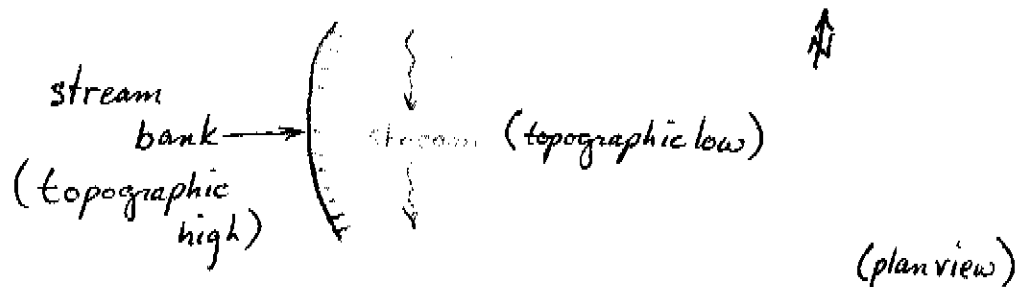
Figure 5.

The second feature is located near Henderson Field in the Matilija quadrangle (plate 3). This feature is in the same location as that which Ziony, et al. (1974) noted as evidence for late Quaternary offset. This feature is actually two crossing escarpments. Assume that the north-south trending escarpment is probably an old stream bank (fig. 5).

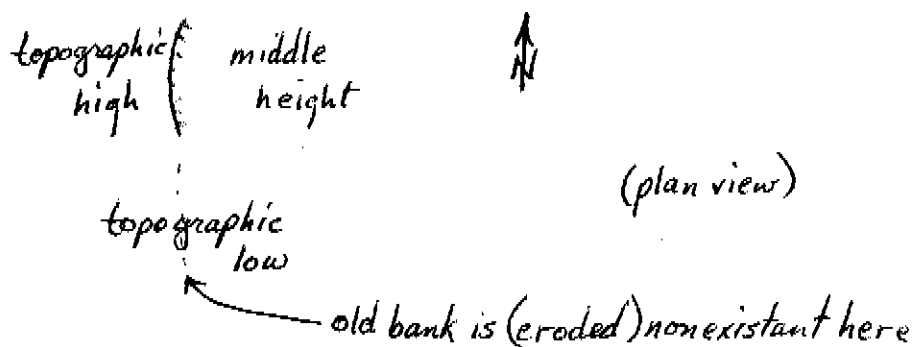
Figure 6.

If the stream changes course, running at right angles to the first flow, then the (south) segment of the old bank would be eroded away (figure 6).

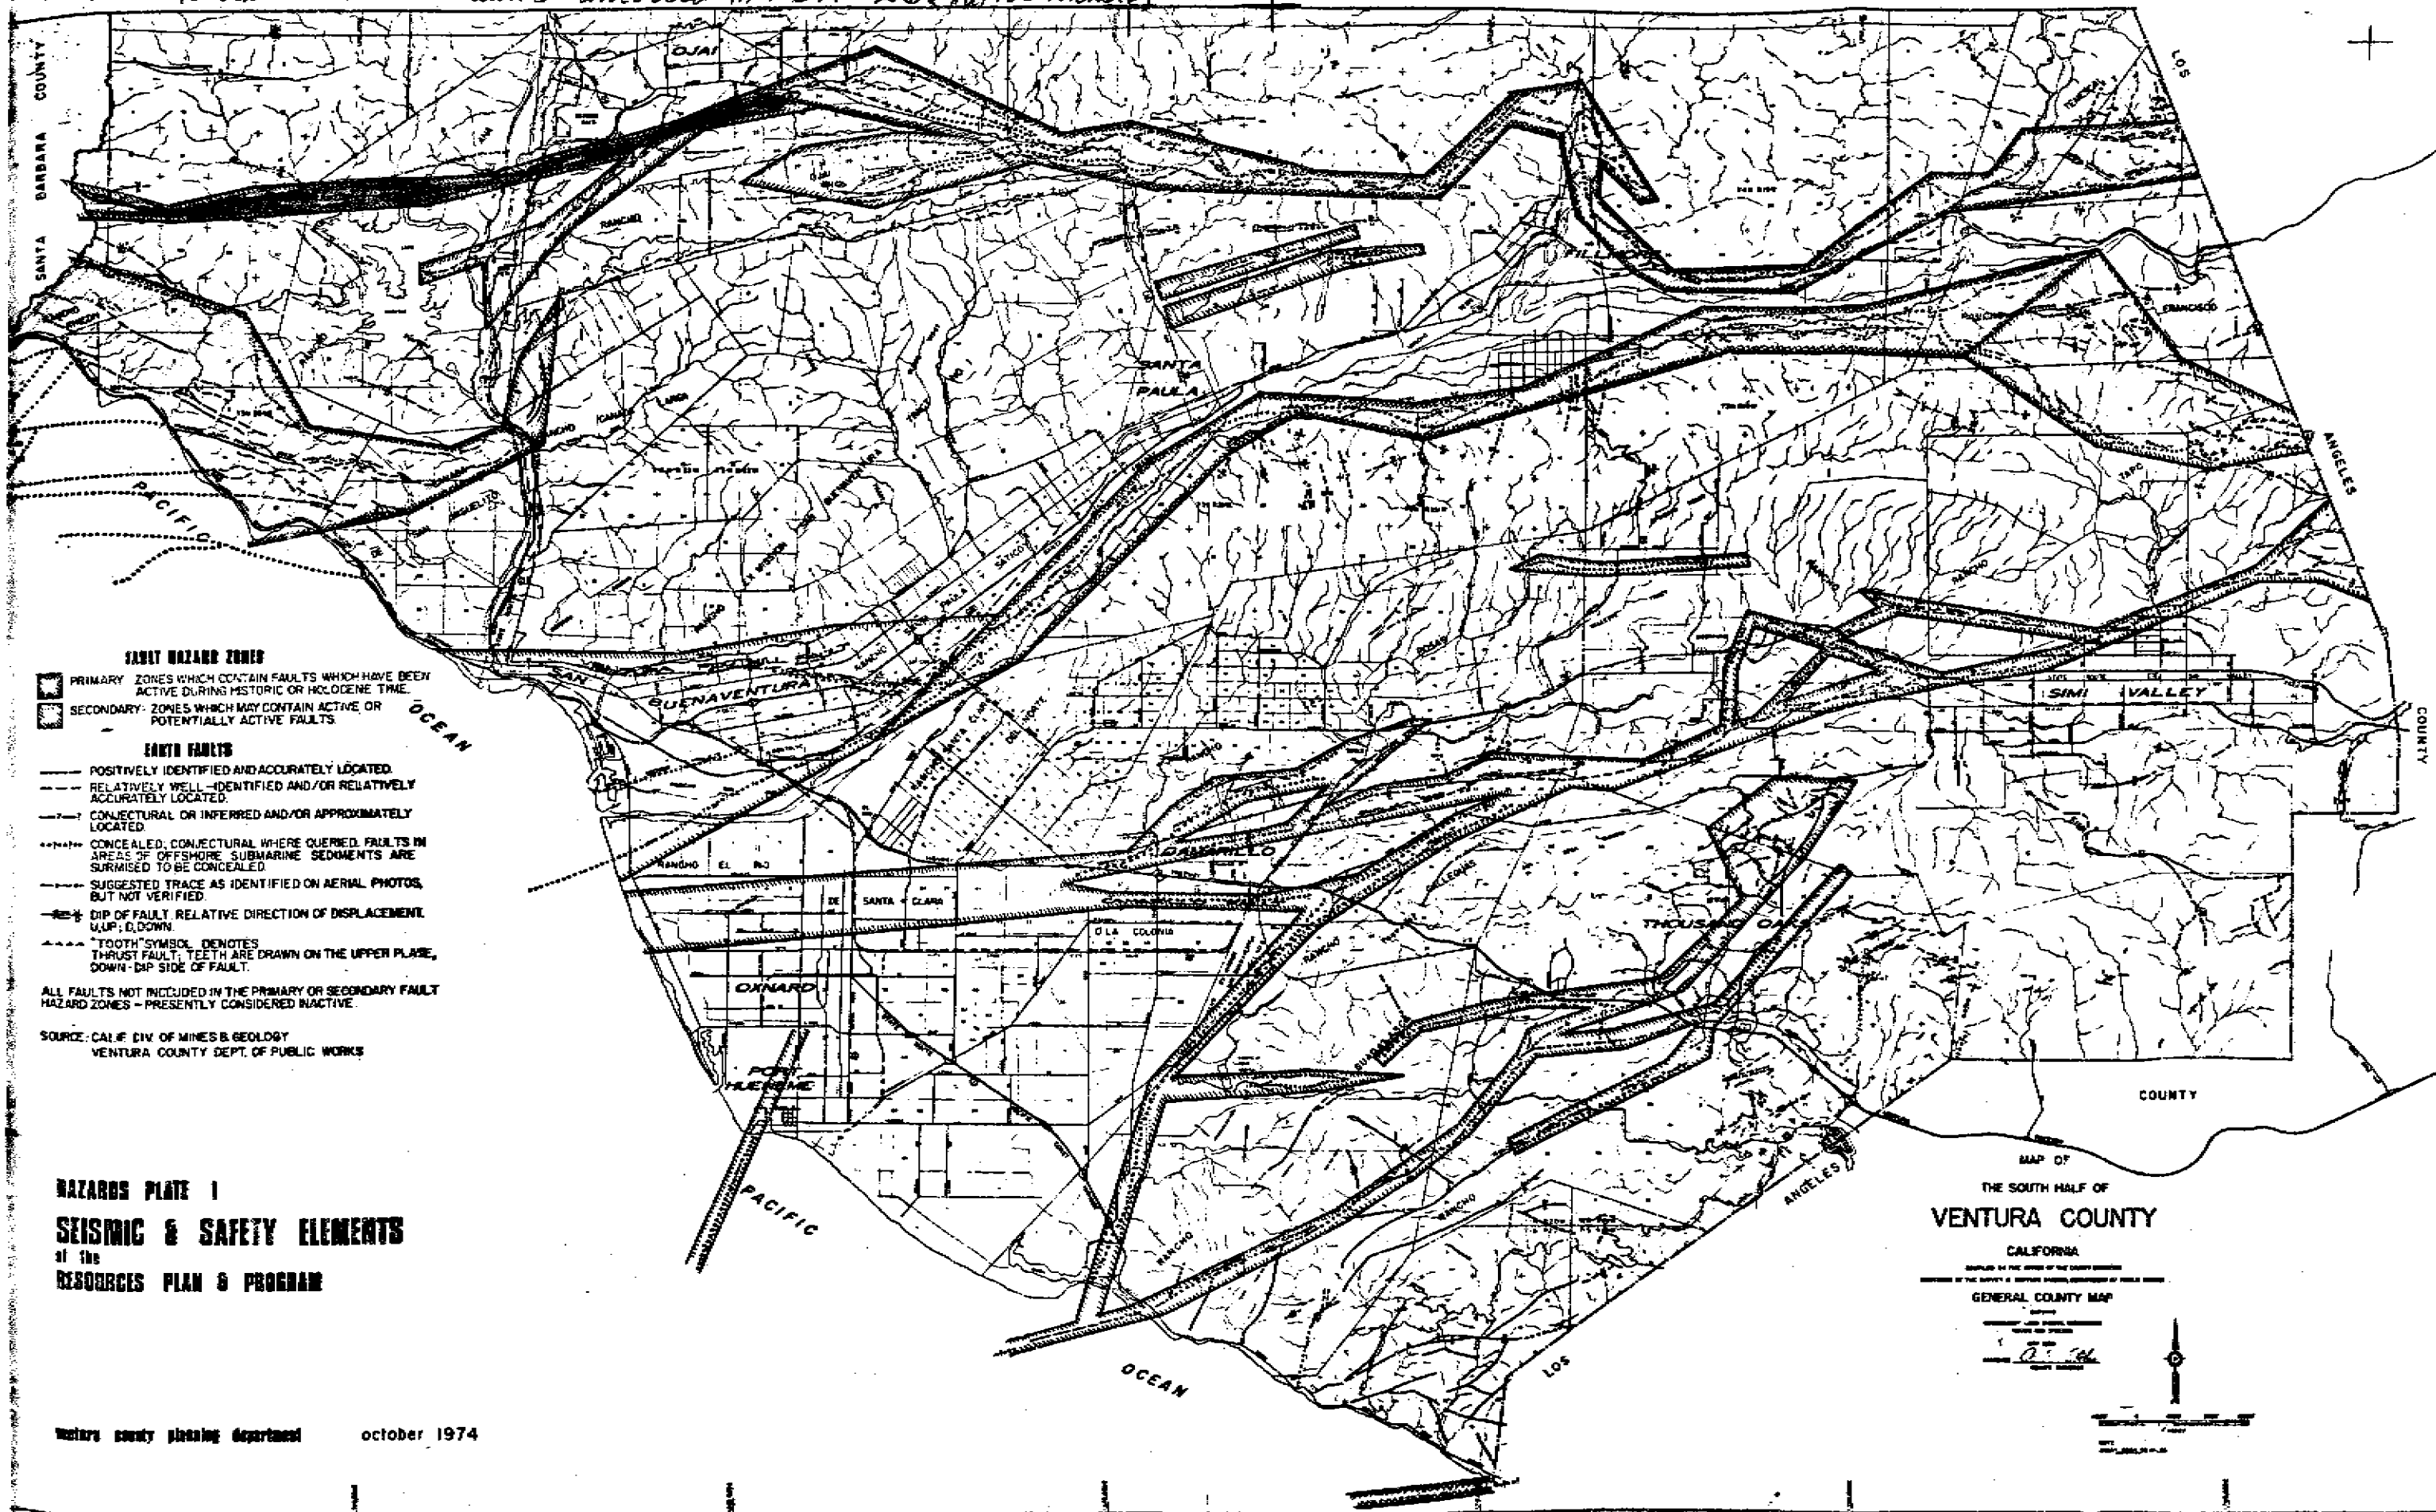
Plate 1. General location of faults discussed in FER-26 (Pattor Nichols, 1974)

The Arroyo Parida and Santa Ana faults are zoned as a secondary fault hazard in the Ventura County Seismic and Safety Element (Nichols, 1974). However, it should be noted that Nichols zoned nearly every fault shown by Weber, et al. (1973), as secondary fault hazards. Nichols considered the Arroyo Parida and Santa Ana faults to be a single fault. Nichols noted that "Evidence as to direction of dip is conflicting." He also noted that no associated earthquake activity has been recorded but that the fault apparently forms a ground water barrier beneath the Ventura River. Using this ground water barrier as his basis, Nichols considered the Arroyo Parida-Santa Ana fault as potentially active. Turner (1971) and Weber, et al. (1975) also confirm this water barrier (see plate 2), however Turner (plate 1 of his report) shows the barrier as entirely in late Pleistocene deposits and not cutting Holocene deposits.
